**Pacific Gas and
Electric Company®**

Serious Incident Communication

Incident Date: 8/20/10

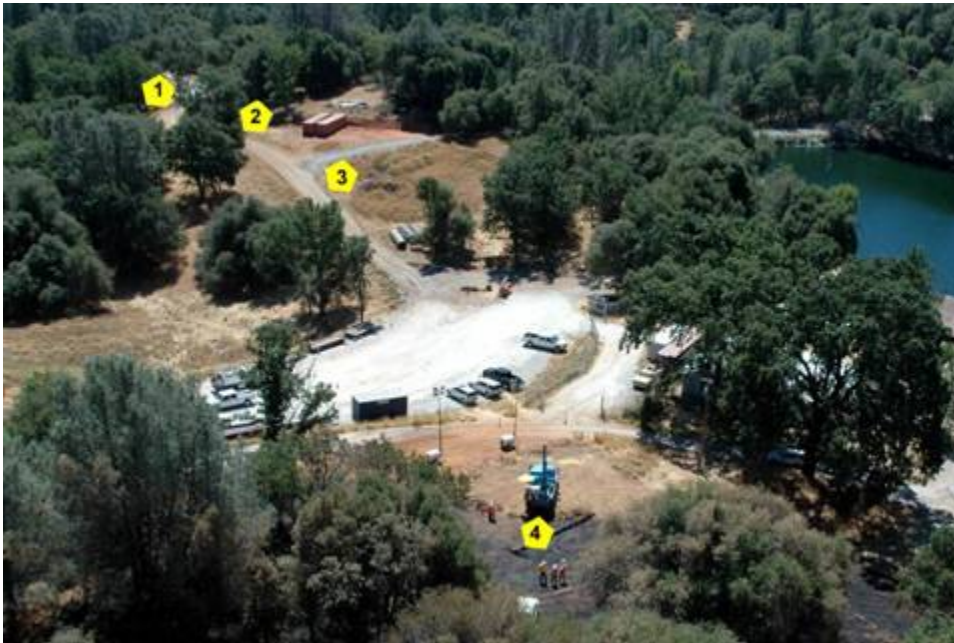
Aerial View of Jobsite:

Numbers correspond to pole hole locations that Jerry was assigned to dig. Incident occurred at location #4.

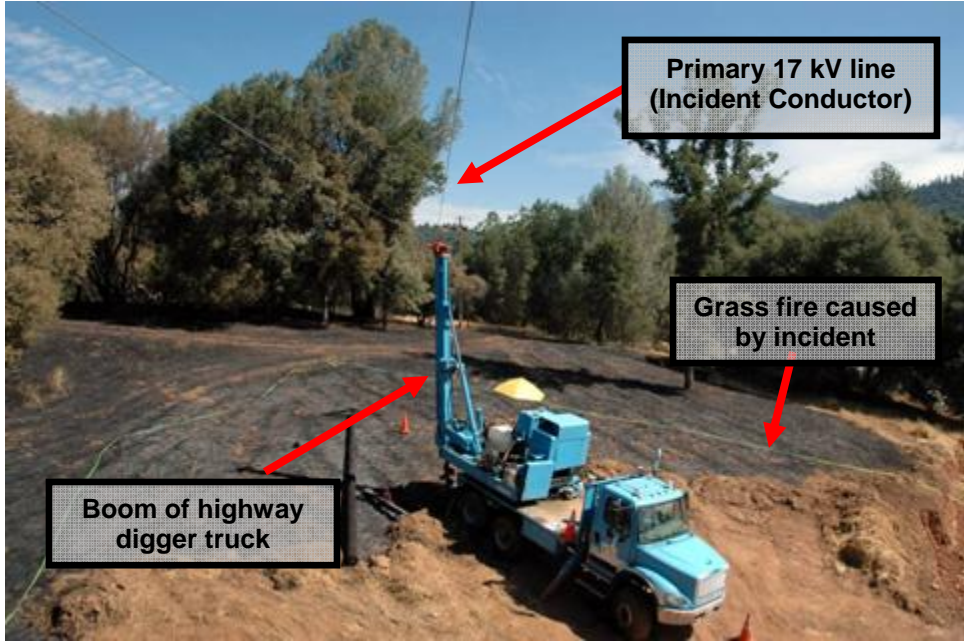
Site of the Incident:

Jerry completed digging three pole holes by approximately 11:30 a.m. before moving to the next location (Hole #4). As Jerry was raising the boom to dig the fourth pole hole, the boom came in contact with one conductor of the overhead single phase 17 kV line, resulting in the vehicle becoming energized at approximately 9800 volts (17 kV to ground voltage). Contact marks were found on the boom guide rollers and conductor indicating that, as the boom was raised, it contacted the conductor for 31 inches before coming to rest.

Hole location #4.

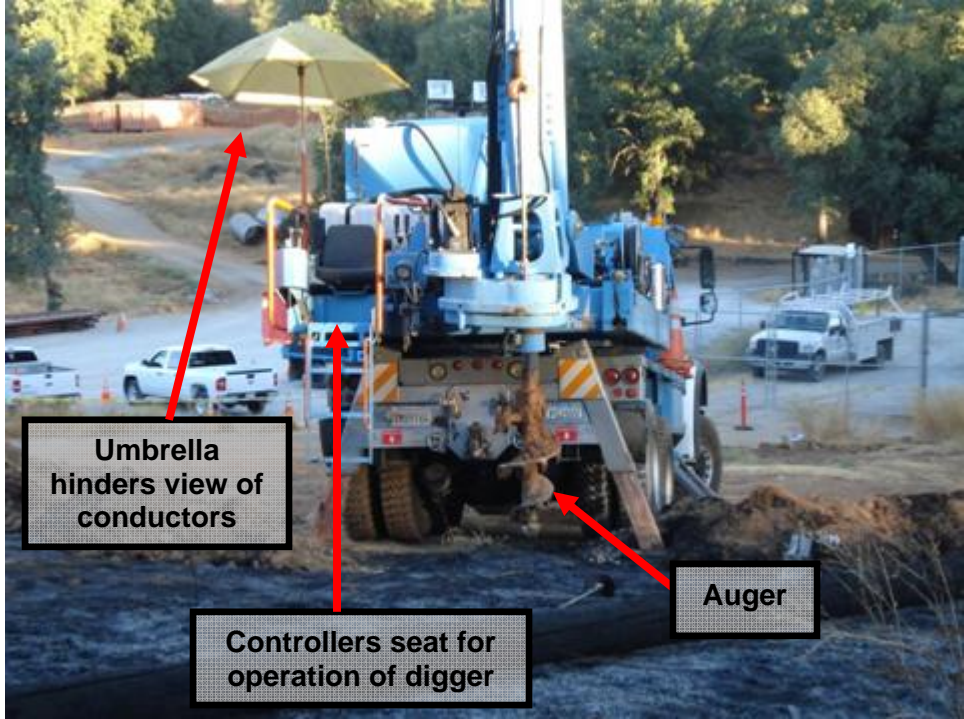
Rear view of highway digger truck:

For some unknown reason, Jerry exited the rear of the vehicle. It has been determined that his leather work gloves and work boots insulated him from touch potential as he exited the energized truck. Analysis of the leather gloves and work boots determined that the gloves provided approximately 2,000 volts of insulation and the boots provided some level of insulation up to approximately 8,000 volts.

- The umbrella attached to the controller seat on the highway digger may have obstructed the view of the overhead conductors.

- the right equipment is used for the job.
5. Develop a relief supervisor leadership training program.
 6. Ensure compliance with USP 1, Employee Conduct (Fitness for Duty)
 - a. Develop a tailboard to reinforce the reporting requirements of USP1, Fitness for Duty and DOT reporting requirements for Class "A" Drivers.
 7. Improve Transportation Services' vehicle line of business specification process.
 - a. Modify all existing highway diggers with umbrella attachments ensuring umbrellas cannot be utilized.

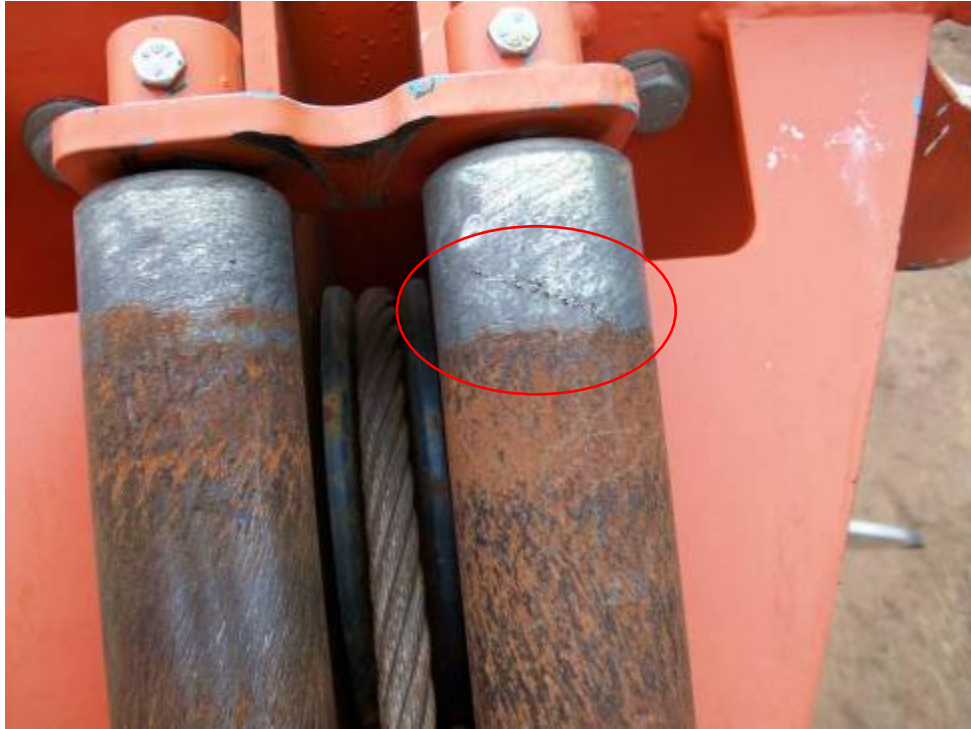
Arcing Marks on Rollers near Top of the Boom:

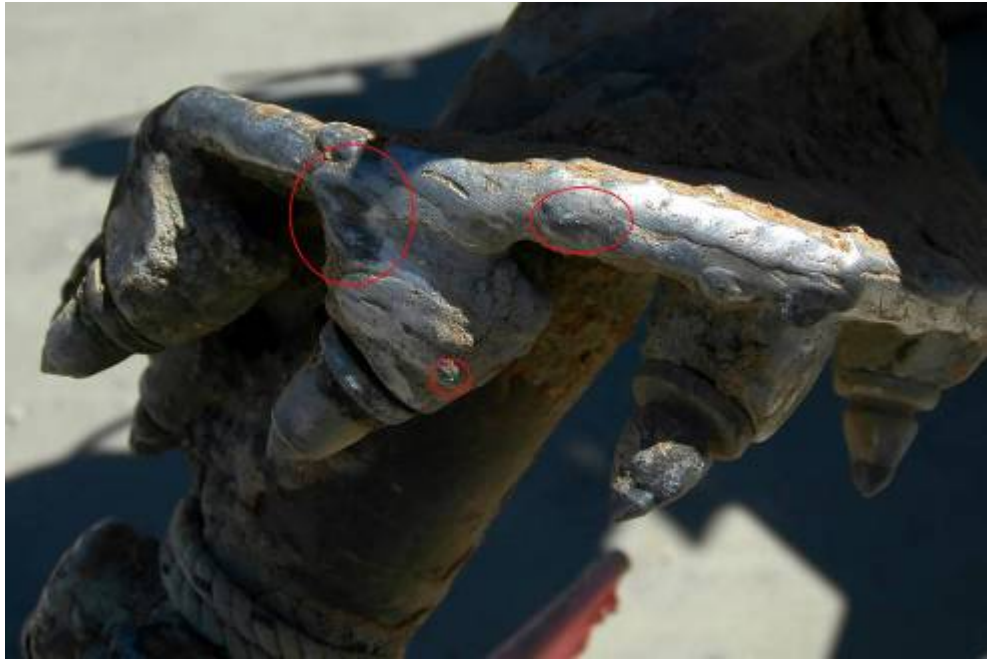
Based on evidence collected, it was determined that Jerry made contact with the auger at his upper left thigh. At this point, the insulation value of Jerry's boots was exceeded, allowing the current to pass through his legs.

Arcing Marks Found on Auger – Approximately 29” from Ground:
